VEHICLE IDENTIFICATION

File #: 78273015

Inspected For: Copart/Houston, TX

Vehicle: 2024 Kia Forte (exact year/trim not confirmed from photos)

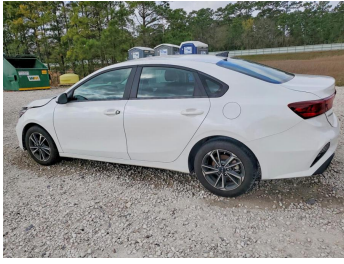
| 1 | Side profile | Side doors, rocker area, rear quarter, rear lamp corner, wheels/tires | No obvious damage visible from this angle; front hood appears raised/misaligned at the front edge (Photo 1). |

- ****Side shown****: Both side profiles are shown (Photo 1, Photo 9). No obvious side-impact dents are visible in these views; the front hood/front corner misalignment is visible from the side.

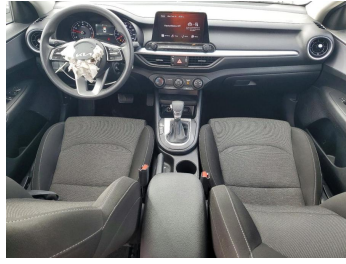
| 2 | Interior front cabin | Steering wheel, dash, center stack, seats | Steering wheel airbag appears deployed (bag material visible at wheel) (Photo 2). No other obvious interior damage visible from this angle. |

No material inconsistencies found. Checked that the VIN is legible and consistent within the photo set (VIN label in Photo 8), reviewed photos for obvious duplication or manipulation artifacts, and compared exterior/interior damage consistency (front-end impact aligns with steering wheel airbag deployment shown in

Photo 2 and Photo 7).

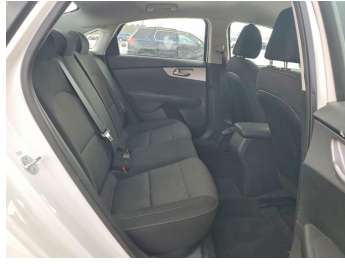
| 3 | Interior rear seating | Rear seat, door trim, glass | No obvious damage visible from this angle (Photo 3). |

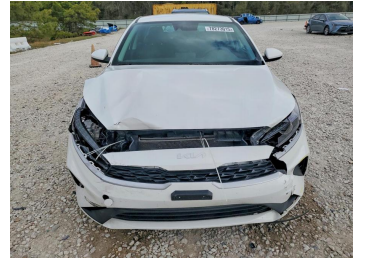
| 4 | Front view | Hood, front bumper cover, grille, headlamp areas, upper tie area | Significant front-end damage: hood buckled with sharp crease; front bumper cover/grille area broken/open; one headlamp area appears missing/damaged; misalignment across front opening (Photo 4). |

The photos document a primary front-end impact with the most severe damage concentrated at the front bumper/grille opening and the hood leading edge (Photo 4, Photo 10). The hood is visibly buckled with a pronounced crease and sits high/misaligned relative to the front fascia, indicating the hood will likely require replacement rather than repair due to the sharp deformation and edge misfit (Photo 4). The front bumper cover and grille area appear broken/open with missing or displaced components, suggesting replacement of the bumper cover and grille assemblies is likely (Photo 4). One headlamp area appears heavily damaged or missing, and the opposite headlamp lens/fitment appears compromised, so replacement of at least one headlamp assembly is anticipated with possible brackets/retainers (Photo 4, Photo 10). The front corner shows scuffing and deformation at the lower bumper corner, consistent with impact and ground contact during the event (Photo 10). Under-hood views show the radiator/condenser stack exposed with the upper front attachments/supports appearing displaced, which commonly drives replacement of the upper tie bar/radiator support components and related fasteners/clips (Photo 12). While the engine itself is visible and no obvious fluid pooling is shown, the open front structure suggests cooling module and support alignment checks would be needed during repair (Photo 12). Interior photos show the steering wheel airbag deployed, which implies supplemental restraint system repairs such as airbag module replacement and post-repair scanning/reset procedures (Photo 2, Photo 7). The instrument cluster displays 25,806 miles, which should be used as the recorded mileage for any estimate preparation (Photo 6). Side profile and rear views do not show obvious damage to doors, rear quarter, trunk, or rear bumper from the provided angles, supporting the front end as the primary damage zone (Photo 1, Photo 9, Photo 11). Given the visible misalignment and missing front-end components, repair planning should include refinish operations for replaced panels (hood and bumper cover) and potential blend considerations into adjacent panels if color match requires it, though blend necessity cannot be confirmed from photos alone (Photo 4, Photo 10). Parts type cannot be confirmed from photos; however, the repair approach described assumes OEM replacement components for safety and fitment consistency.

- Body labor: 22.0 hrs (front bumper R&R/fit, hood R&R/align, headlamp R&R, radiator support/tie components R&R, misc. R&I for access, aim/checks)
- Paint labor: 10.0 hrs (refinish hood and front bumper cover; allowance for adjacent edge work)
- Paint & materials: 10.0 hrs x \$45/refinish hr = \$450
- Mechanical/Electrical labor: 6.0 hrs (SRS service actions, scan procedures, possible cooling module R&I support)

- Hood assembly: \$650
- Front bumper cover: \$450
- Grille/center trim components: \$250
- One headlamp assembly: \$900
- Headlamp brackets/retainers/fasteners (allowance): \$150
- Radiator support/upper tie components (allowance): \$450
- Energy absorber/impact bar components (allowance): \$350
- Steering wheel airbag module: \$1,200
- SRS related components allowance (sensors/clock spring/fasteners as needed): \$400

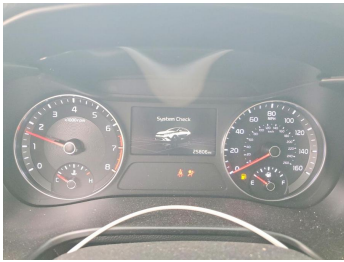
| 5 | Instrument cluster | Odometer display, warning indicators | Odometer reads 25,806 miles (Photo 5/Photo 6 show same cluster view; mileage legible in Photo 6). Warning lights present consistent with airbag deployment (Photo 5). |

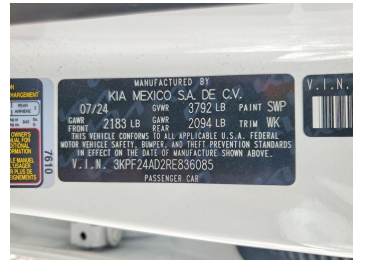
| 8 | VIN/door label close-up | Manufacturer label with VIN and build info | VIN label legible: 3KPF24AD2RE836085; manufacture date shown as 07/24 on label (Photo 8). |

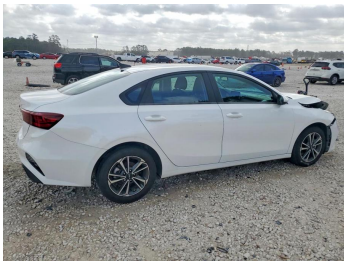
| 9 | Side profile | Side doors, rear quarter, wheels/tires, front corner visible | No obvious damage visible along the side profile; front corner shows hood raised/misaligned and front-end damage at the nose (Photo 9). |

- ****Opposite side shown****: The opposite side is also shown via the other profile view (Photo 1 vs Photo 9). No obvious damage visible away from the front end; front corner damage remains the primary visible issue.

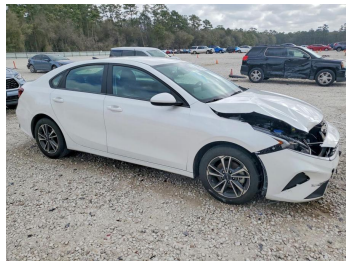
| 10 | Front corner/three-quarter | Hood, one fender area, one headlamp area, bumper corner | Front corner damage visible: hood buckled and lifted; one headlamp area appears damaged/missing; bumper corner scuffed/deformed; gaps/misalignment at hood-to-fender/bumper interfaces (Photo 10). |

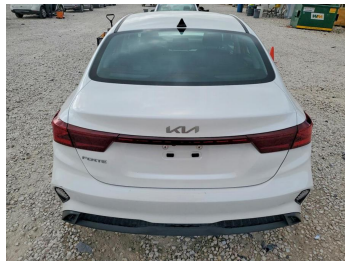
| 11 | Rear view | Trunk lid, rear bumper cover, tail lamps | No obvious damage visible from this angle (Photo 11). |

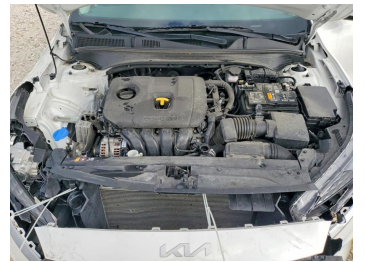
| 12 | Under-hood/front structure view | Radiator/condenser area, upper tie area, engine bay components | Front opening shows displaced/broken upper front components; radiator/condenser stack visible and appears exposed; exact leakage not visible; supports/attachments likely damaged based on open front and misalignment (Photo 12). |
