VEHICLE IDENTIFICATION

File #: 42012876

VIN: 1FMUK7KH5SGC94881

Vehicle: 2025 Ford Explorer (trim/year not confirmed from photos)

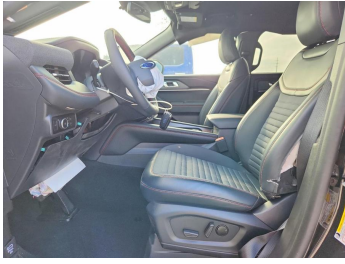
| 1 | Interior front seating area | Steering wheel, front seats, dash lower area | Steering-wheel airbag appears deployed (bag visible at wheel). One front seat outer bolster shows a tear/damage at the side (Photo 1). |

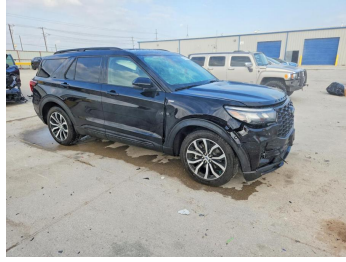
| 6 | Exterior front 3/4 (opposite side) | Front bumper corner, headlamp, grille, hood edge, fender edge, wheel | Front bumper cover at one front corner shows tearing/creasing and displacement; lower bumper/valance area appears pulled down/out of position; scuffing visible around the damaged corner (Photo 6). |

The visible primary impact appears concentrated at one front corner, where the front bumper cover is torn/creased and pulled out of alignment, with the lower bumper/valance area hanging or displaced (Photo 6, Photo 11). The grille and one headlamp are visible in the front views; while the headlamp lens appears present, the surrounding bumper-to-lamp area shows distortion consistent with the bumper cover damage (Photo 6, Photo 11). The hood appears closed and generally aligned in the front view, but the photos do not provide close gap measurements at the hood-to-fender or hood-to-lamp interfaces (Photo 11). The windshield shows extensive cracking across a large portion of the glass, indicating it will likely require replacement rather than repair (Photo 11). Underhood imagery shows the engine bay from above; no obvious displaced major components are visible, but the photo angle does not confirm the condition of the radiator, condenser, cooling fans, or lower reinforcement/absorber behind the bumper (Photo 3). Interior photos show the steering-wheel airbag deployed, which implies SRS-related repairs and post-repair scanning/calibration considerations may be necessary depending on vehicle equipment (Photo 1, Photo 8). A torn opening with airbag fabric visible on the side of one front seatback suggests a seat-mounted airbag deployment or related trim damage, and the seat cover/trim would likely require replacement or upholstery repair (Photo 10). One front seat outer bolster also shows a visible tear/damage area, supporting the need for seat trim repair/replacement beyond simple cleaning (Photo 1). Rear exterior views show no obvious collision damage to the liftgate, rear bumper, or tail lamps from the provided angles, though minor scuffs could be obscured by water/dirt on the surfaces (Photo 5, Photo 9, Photo 12). Side profile views show no obvious dents in the doors or quarter panels, but reflections and lighting can mask shallow damage, and close-ups of the damaged front corner fender edge are limited (Photo 2, Photo 6). VIN is confirmed from the manufacturer label as 1FMUK7KH5SGC94881 (Photo 4). The odometer display shows 3,253.8 miles; this is photo-based and should be treated as an observed reading at time of photo capture (Photo 13). Overall, the photo set supports a front-corner cosmetic/bumper damage event with significant glass damage and confirmed airbag deployment, which typically increases repair complexity due to SRS parts and required diagnostic procedures (Photo 6, Photo 11, Photo 1).

- Front bumper cover (one-piece cover) = \$850
- Front lower valance/air deflector/trim set (as applicable) = \$250
- Bumper absorber/energy foam = \$180
- Bumper bracket/retainer set (one corner) = \$120
- Windshield glass (with molding/kit) = \$650
- Steering wheel airbag module = \$1,200
- Seat-mounted airbag module (one front seat) = \$1,400
- SRS control module (if required after deployment) = \$600
- Seat trim/cover repair or replacement allowance (one front seat) = \$500
- Clips/fasteners/misc hardware allowance = \$100

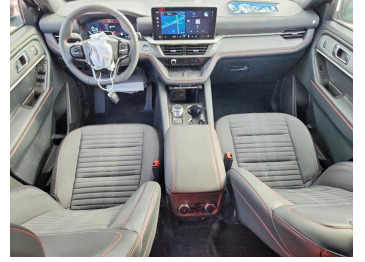
| 8 | Interior wide front cabin | Steering wheel/airbag, instrument panel, center screen/console, front seats | Steering-wheel airbag deployed (bag visible). No other obvious interior damage visible from this angle (Photo 8). |

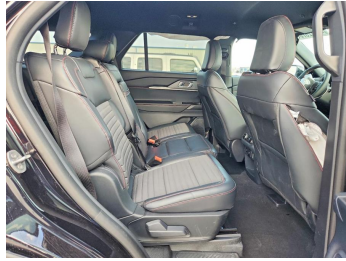
| 10 | Interior rear seating area (side view) | Rear seats, door trim, back of front seat | Back of one front seat shows a torn opening with airbag fabric visible (seat-mounted airbag deployment suspected based on visible fabric/tear) (Photo 10). |

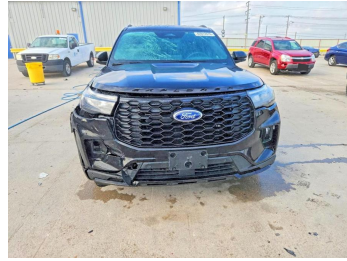
| 11 | Exterior front view | Front bumper, grille, one headlamp, hood edge, windshield | One front corner of bumper cover visibly damaged/torn; windshield shows heavy cracking across much of the glass (Photo 11). |

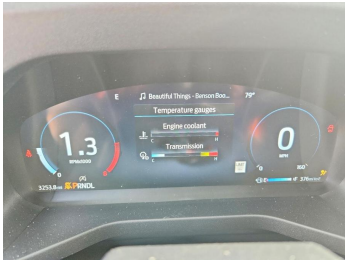
| 13 | Instrument cluster close-up | Speedometer/tach display, warning indicators, odometer | Odometer reads 3253.8 miles (Photo 13). Warning indicators present; photo does not confirm specific fault causes (Photo 13).
